**TURNING POINT COMMUNITY CHURCH**

# EL CHAGUE 1 COMMUNITY

LEON, LEON, NICARAGUA

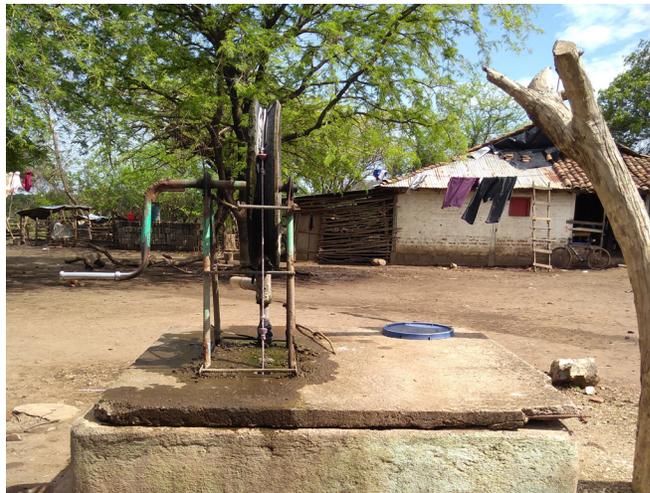
The community members of El Chague 1 suffered greatly from the lack of safe water in their community. The 16 household could claim only one hand-dug well as their own. It was old, dysfunctional, and contaminated. Aware of this, they tried to supplement their water with water sources in nearby communities. However, the hand-dug wells in the surrounding area were all in the same condition as their own. They continually searched farther and farther for respite, only to find none available.

This hand-dug well spreads illness throughout the community.

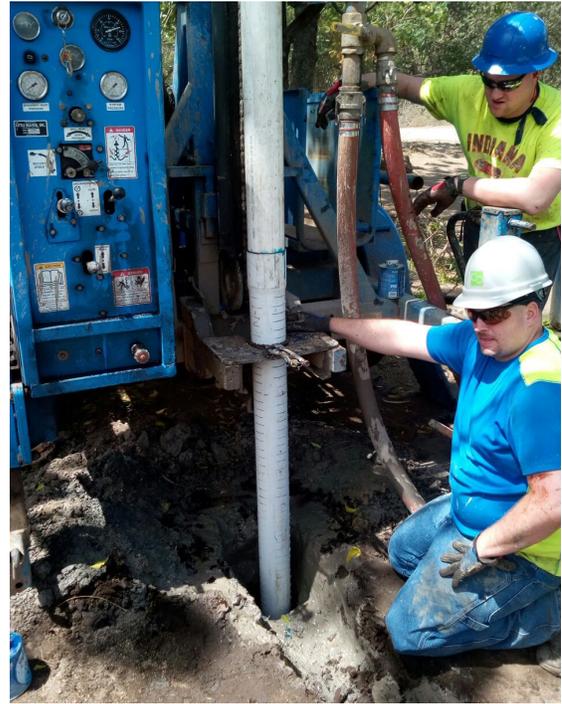
The Living Water Trips team helps dig a new well.

The community members were overjoyed to welcome the Living Water staff, who returned to El Chague 1 with a drilling rig and a Living Water Trips team. The Living Water team drilled 41 meters into the earth to reach an aquifer of safe water. They installed a PVC pipe, gravel pack, and sanitary seal. They treated the well with a shock chlorination and tested the water's quality to ensure its safety. The well was capped with a hand pump and handle. Finally, the Living Water team laid a concrete base, and the well was complete.

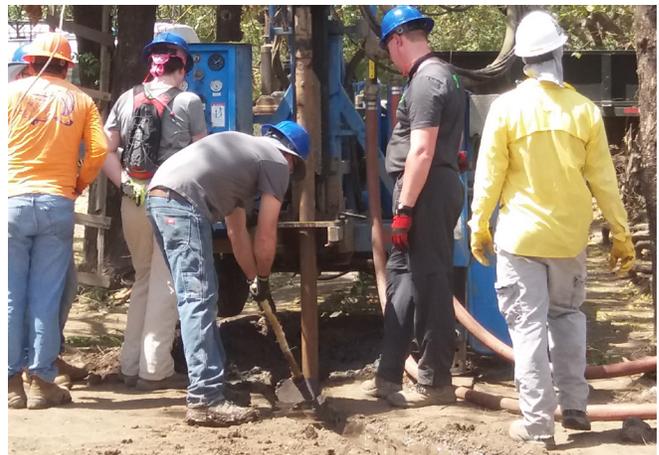
Construction is under way.

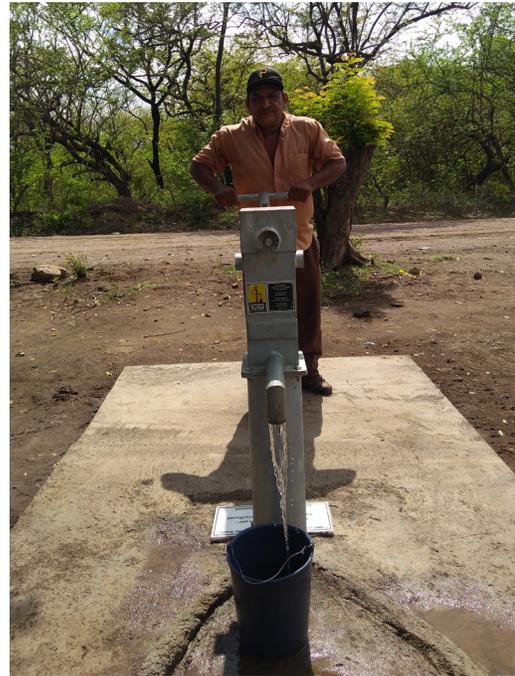
A community member practices pumping water for the first time.
