# WELL #3 FINAL REPORT

## HONDURAS Elixir, Colon, Sabá

# CALVARY BAPTIST CHURCH

# WATER

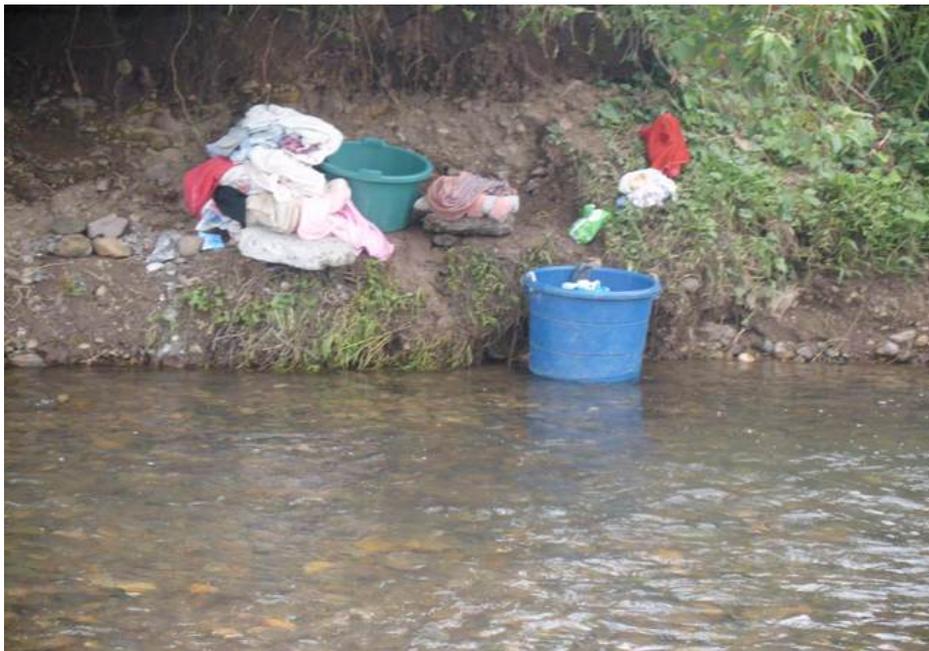
The community was forced to use surface water like this to meet all of their water needs.

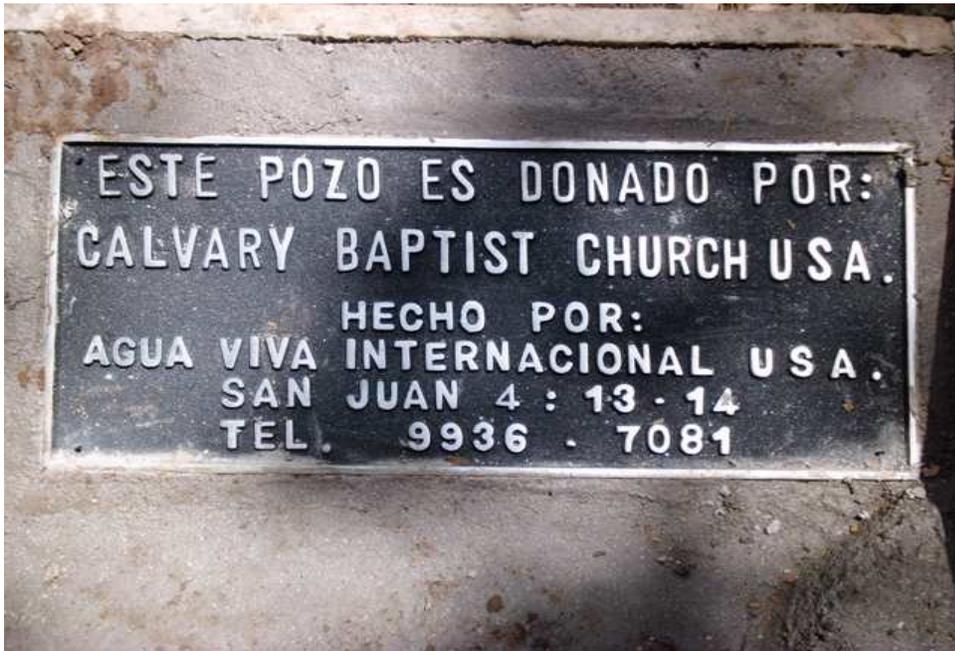
Close up of the plaque on the pump.

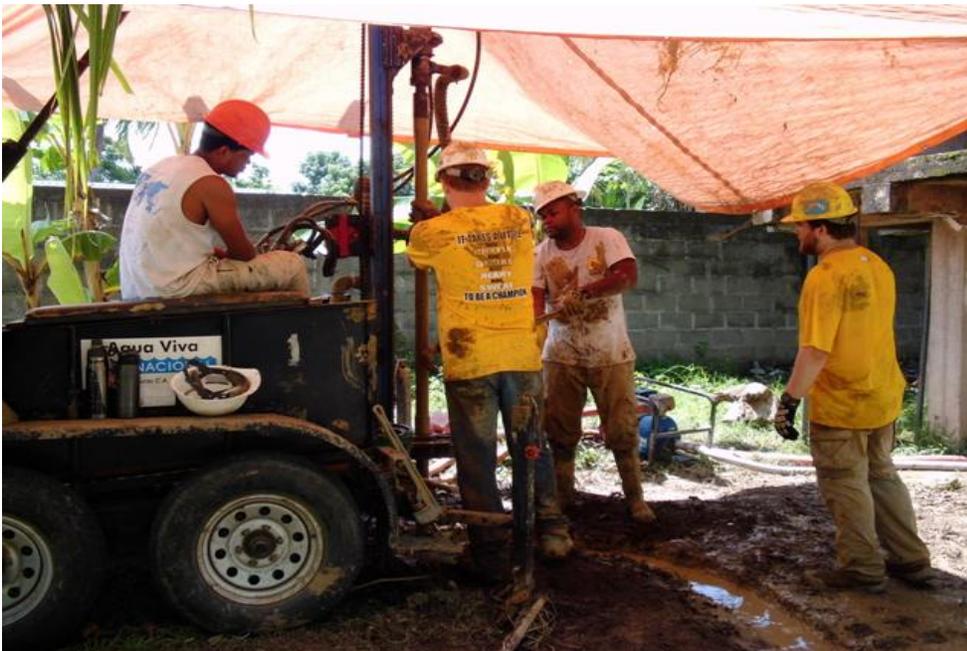
The Living Water Honduras team drilling the new borehole for the community.

Altitude	85 m	
Total depth drilled	23 m	
Static level	13 m	
Total depth of casing	23 m	
External Diameter of casing	100 mm	
Casing material	PVC	
Screen	Start: 20m	Stop: 23 m
Pump Type	Afridev	
Depth of cylinder	18 m	
Gravel Pack	No	
Gravel Pack Depth	9	
Well yield	208 Liters/minute	
Sanitary seal depth from surface	15 m	
Shock Chlorination	Yes

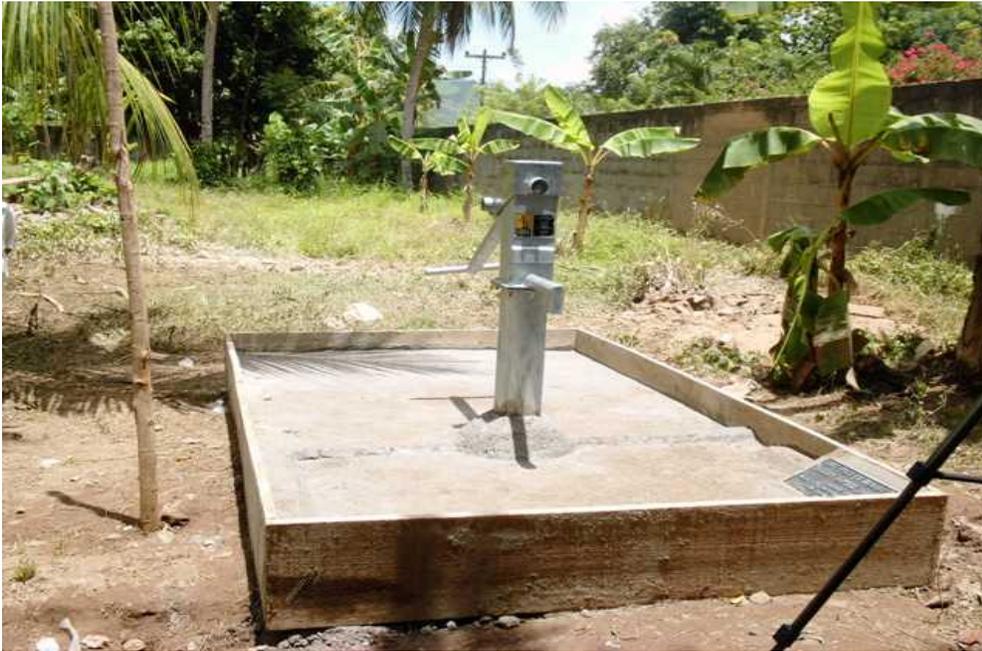
The completed water project with cement base, Afridev hand pump, and plaque.

Platform is concrete with reinforcing steel	Yes	
Dimension of Platform (H*W*L)	.25*1.8*3	
Drainage Channel or soak pit installed	Yes

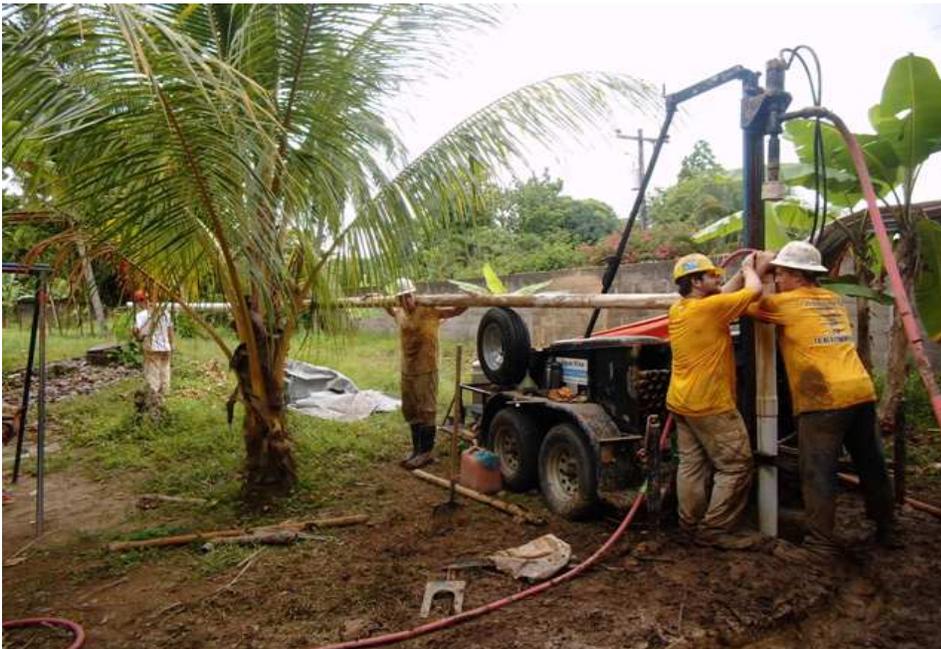
The team gets ready to develop the well.

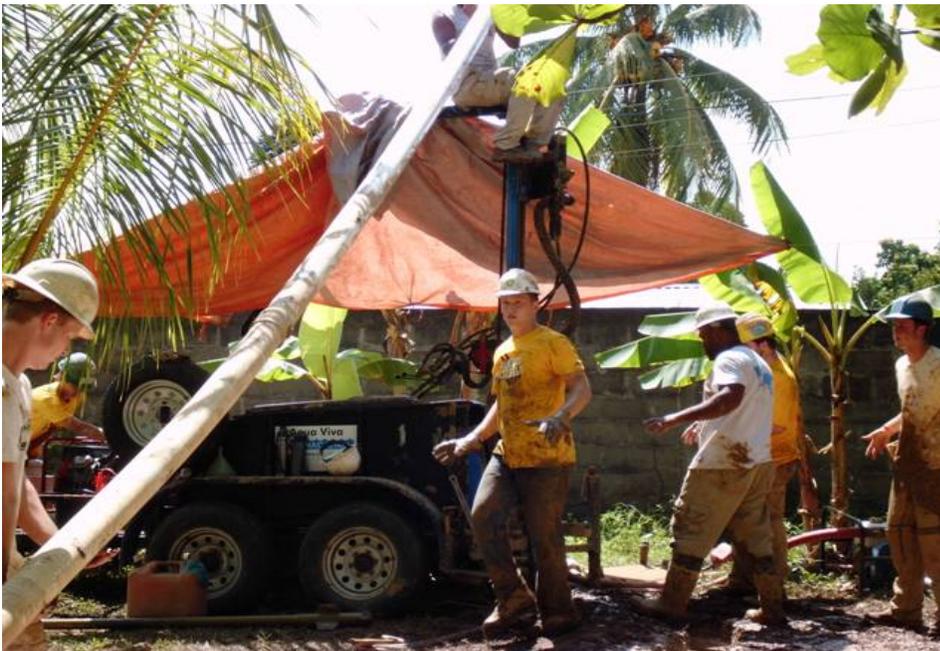
The Living Water Honduras drilling team get ready to install the PVC pipe into the well.

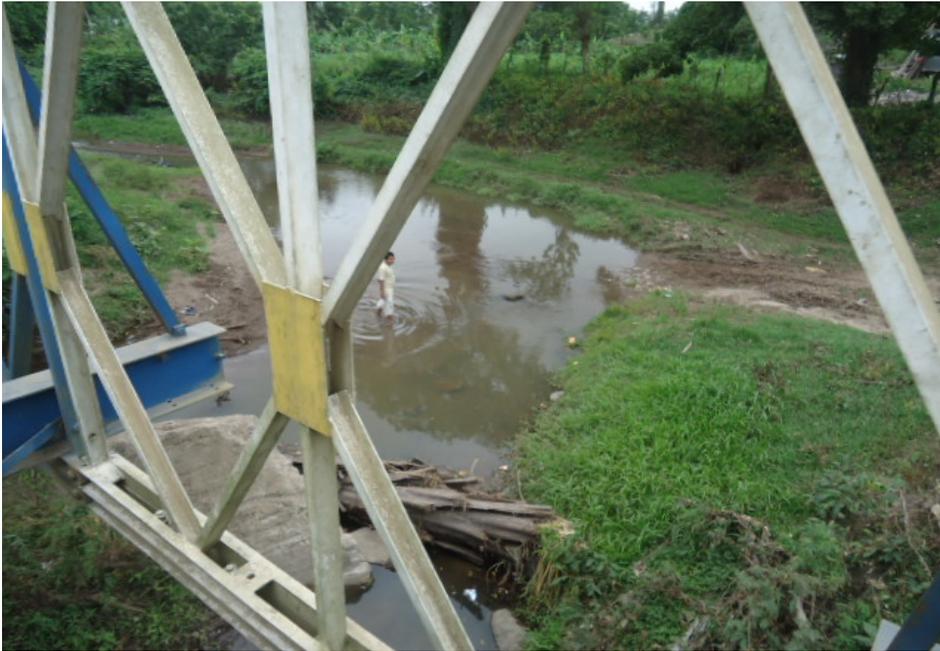
One of the previous water sources that the community relied on to meet their growing water needs.

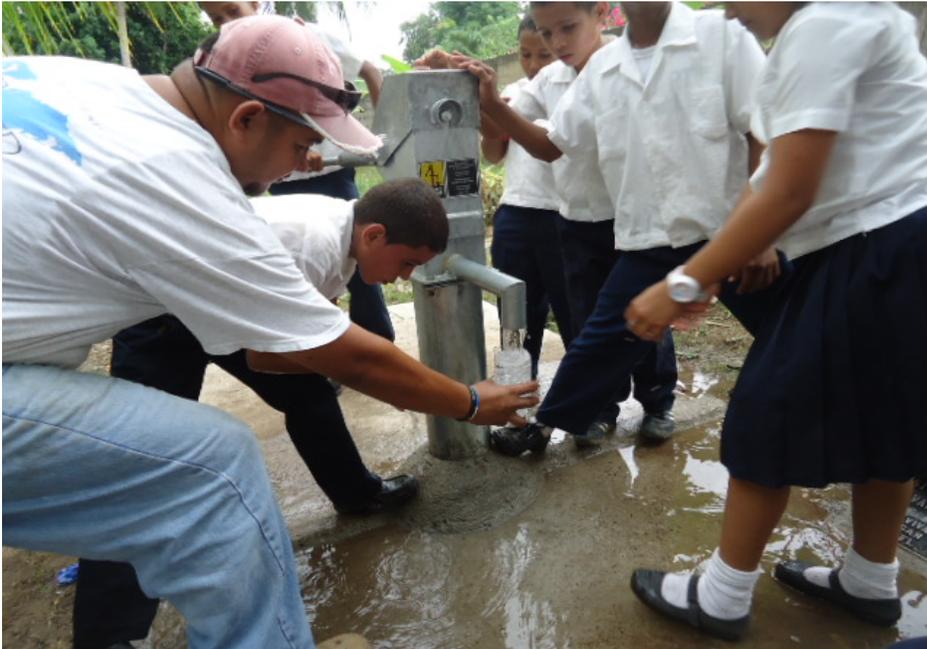
A Living Water Honduras member gathers water for quality testing.

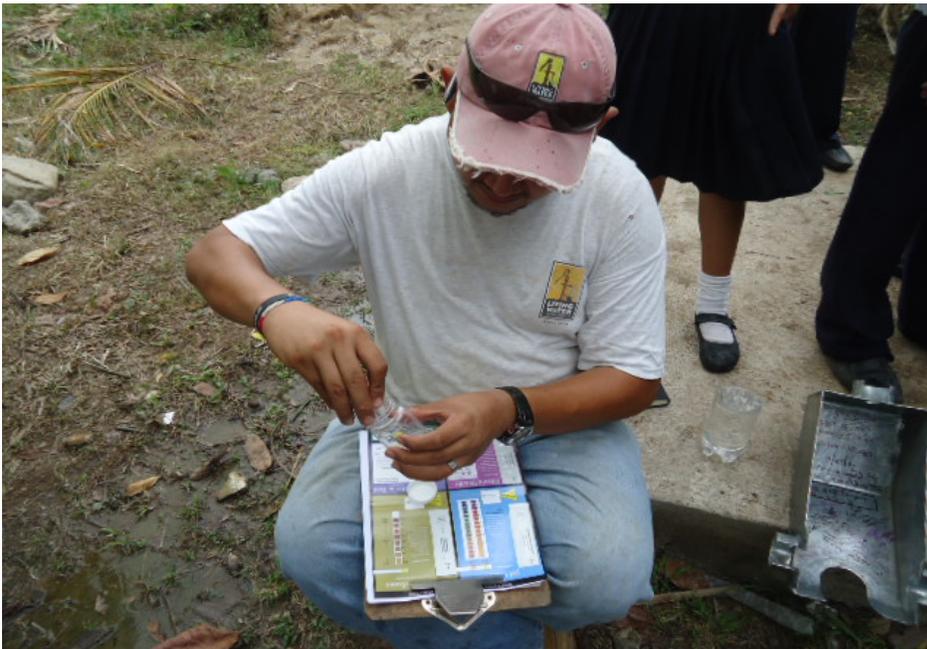
The water is tested for pH level, hardness, nitrates/nitrites, and the presence of coliform bacteria.

Water Purity Test	LWI test Kit
	Total Dissolved Solids (as per T.D.S meter) : 129
	pH: 6
	Total Hardness: 0 Ppm
	Nitrate/Nitrites: 0 Ppm
Bacteria Test	Coliform Bacteria NOT detected ( Colorless or Light Yellow color)
